**Re: Village of Jemez Springs Wastewater Treatment Plant; Minor Municipal; SIC 4952;
NPDES Compliance Evaluation Inspection; NM0028011; May 23, 2017**

NPDES Compliance Inspection Report

Compliance Evaluation Inspection
Village of Jemez Springs Wastewater Treatment Plant
NPDES Permit NM0028011
May 23, 2017
Page 1 of 8

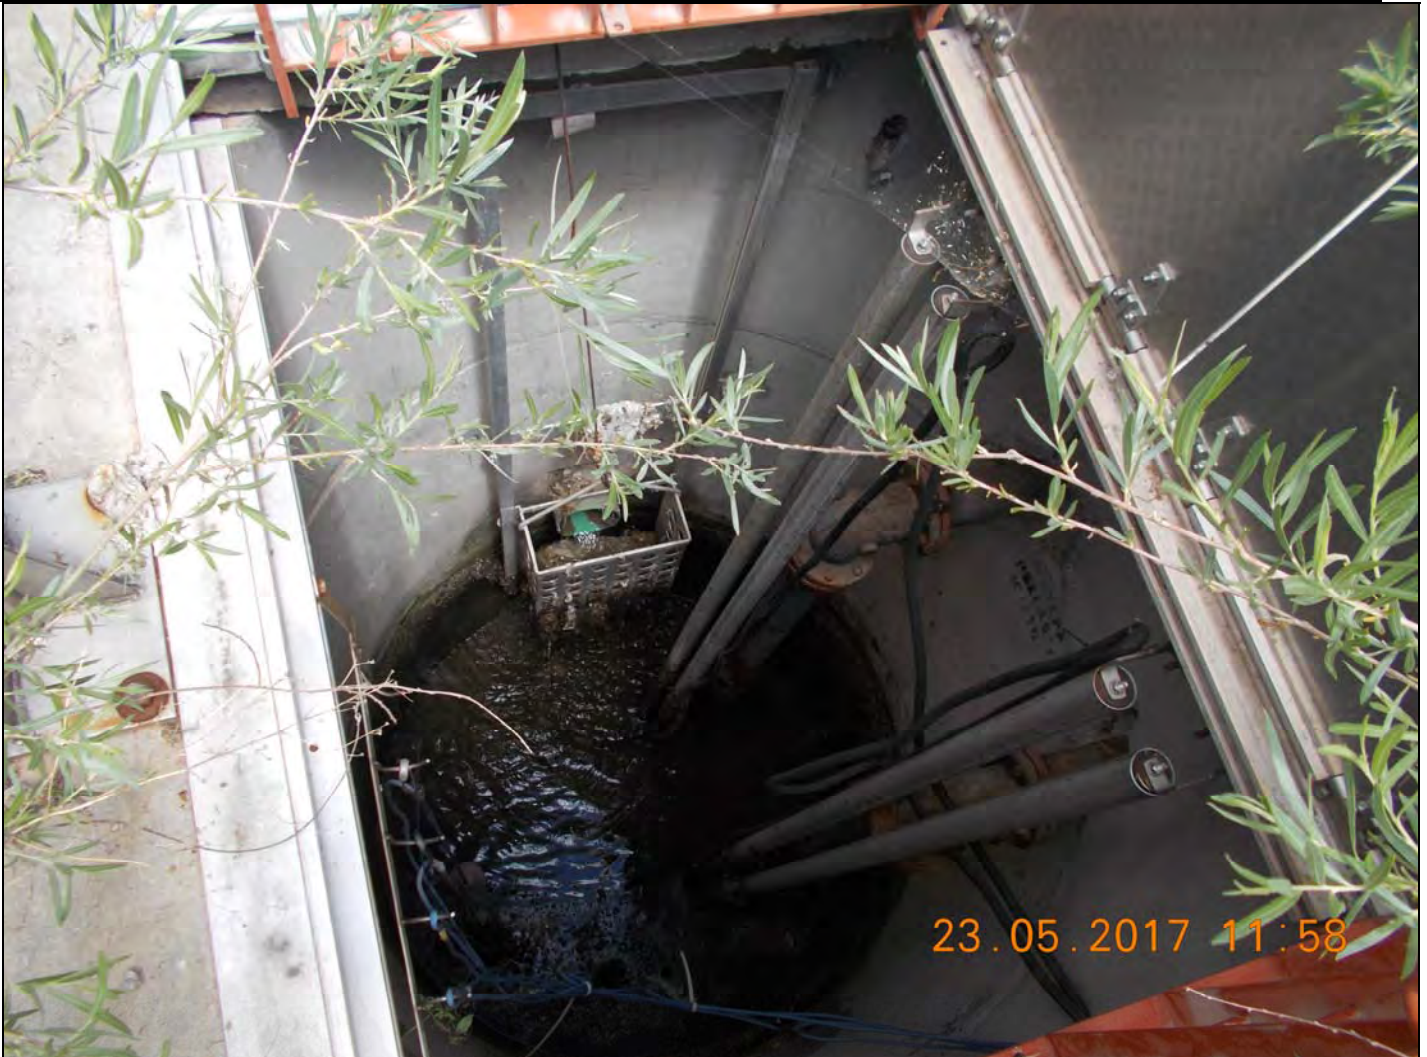
Subject: Headworks lift station with hanging basket to collect solids and 2 Flygt Pumps to lift raw sewage to the treatment works. The solids catch basket is difficult to maneuver and clean for the operators and often becoming ineffective allowing large solids to pass through.

1. Influent Solids Removal has improved since the last inspection with the new baskets at the pre-activation- equalization basins.
2. Ferric Chloride dosing for Phosphorous Removal – storage and containers. This area does not have secondary containment, corrosion was observed throughout the storage building and staining on the ground was observed outside the building.

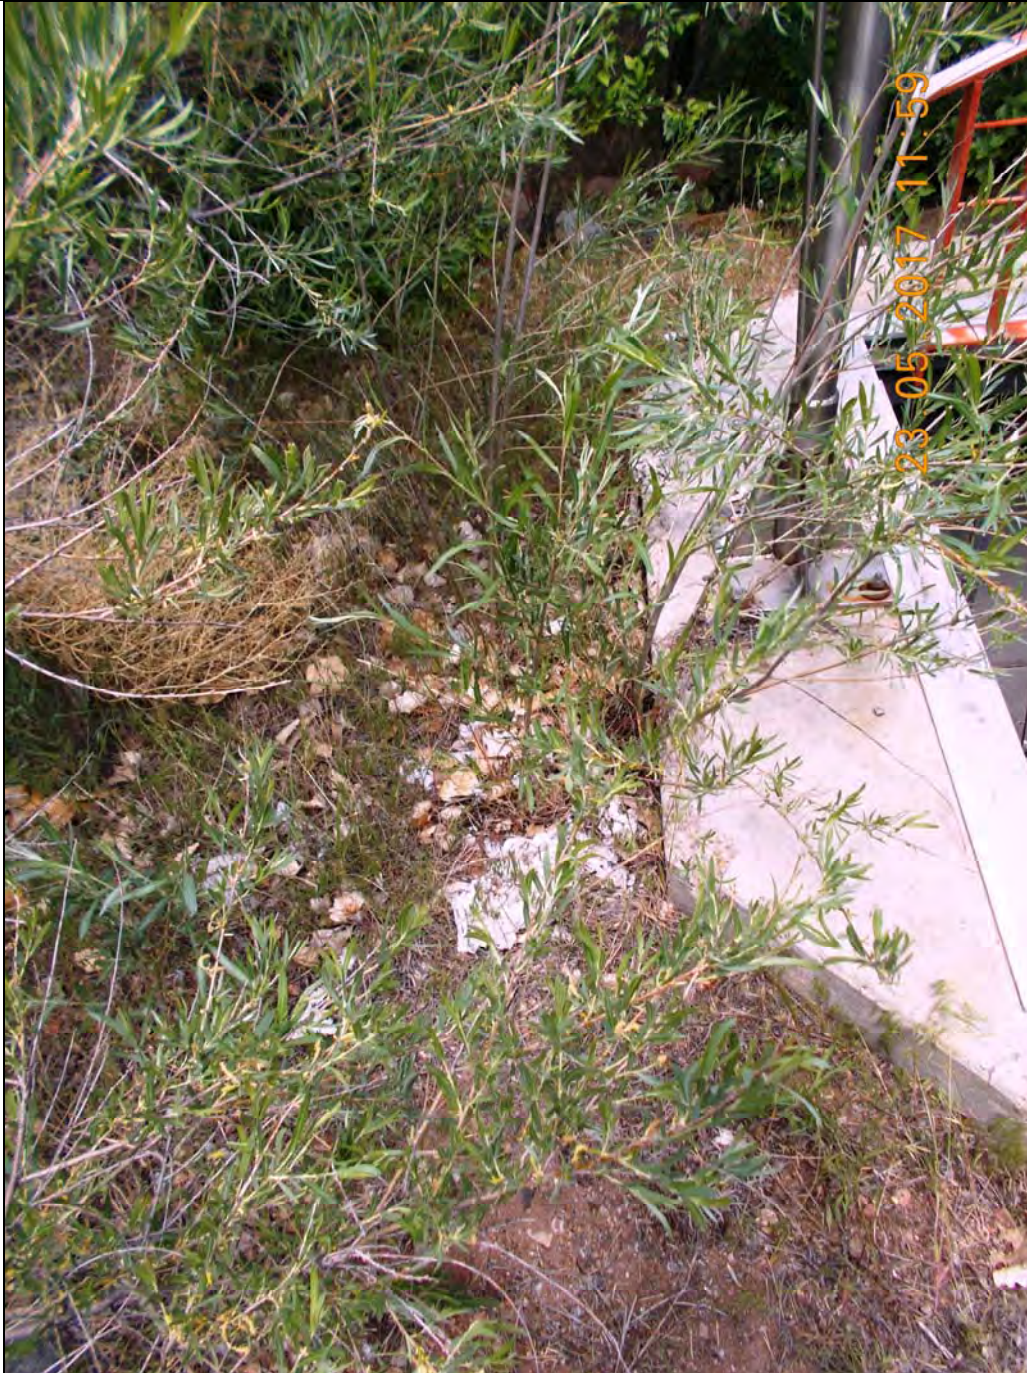
**NMED/SWQB
Official Photograph Log
Photo # 3**

Subject: At the headworks, solids scraping were observed on the bare ground that is less than 50 feet from the Jemez River.

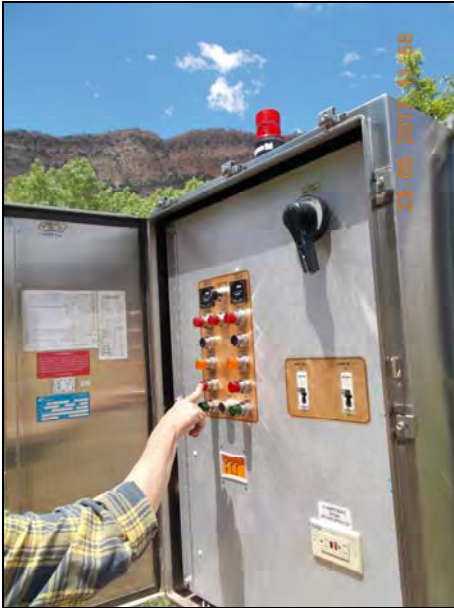
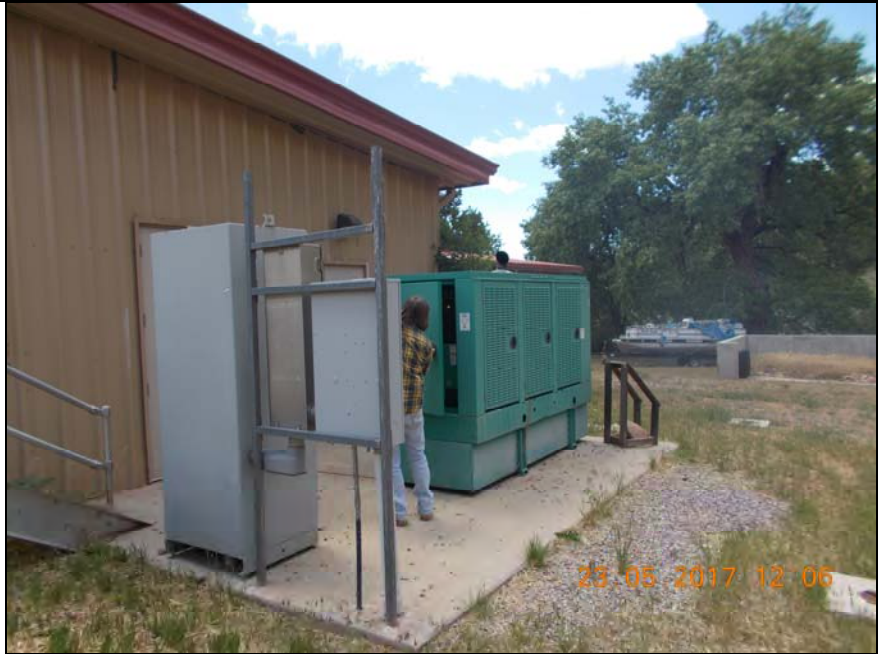
**NMED/SWQB
Official Photograph Log
Photo # 4 & 5**

Subject: Alarm system at the headworks lift station flashes a light when a problem is detected. If operators do not see it, residents call in to the Village. A call out relay is also in place.

A back up diesel generator powers up if there is an interruption to the electricity at the facility. Frequent power outages occur and the generator is run on a nearly weekly basis, according to a facility operator.

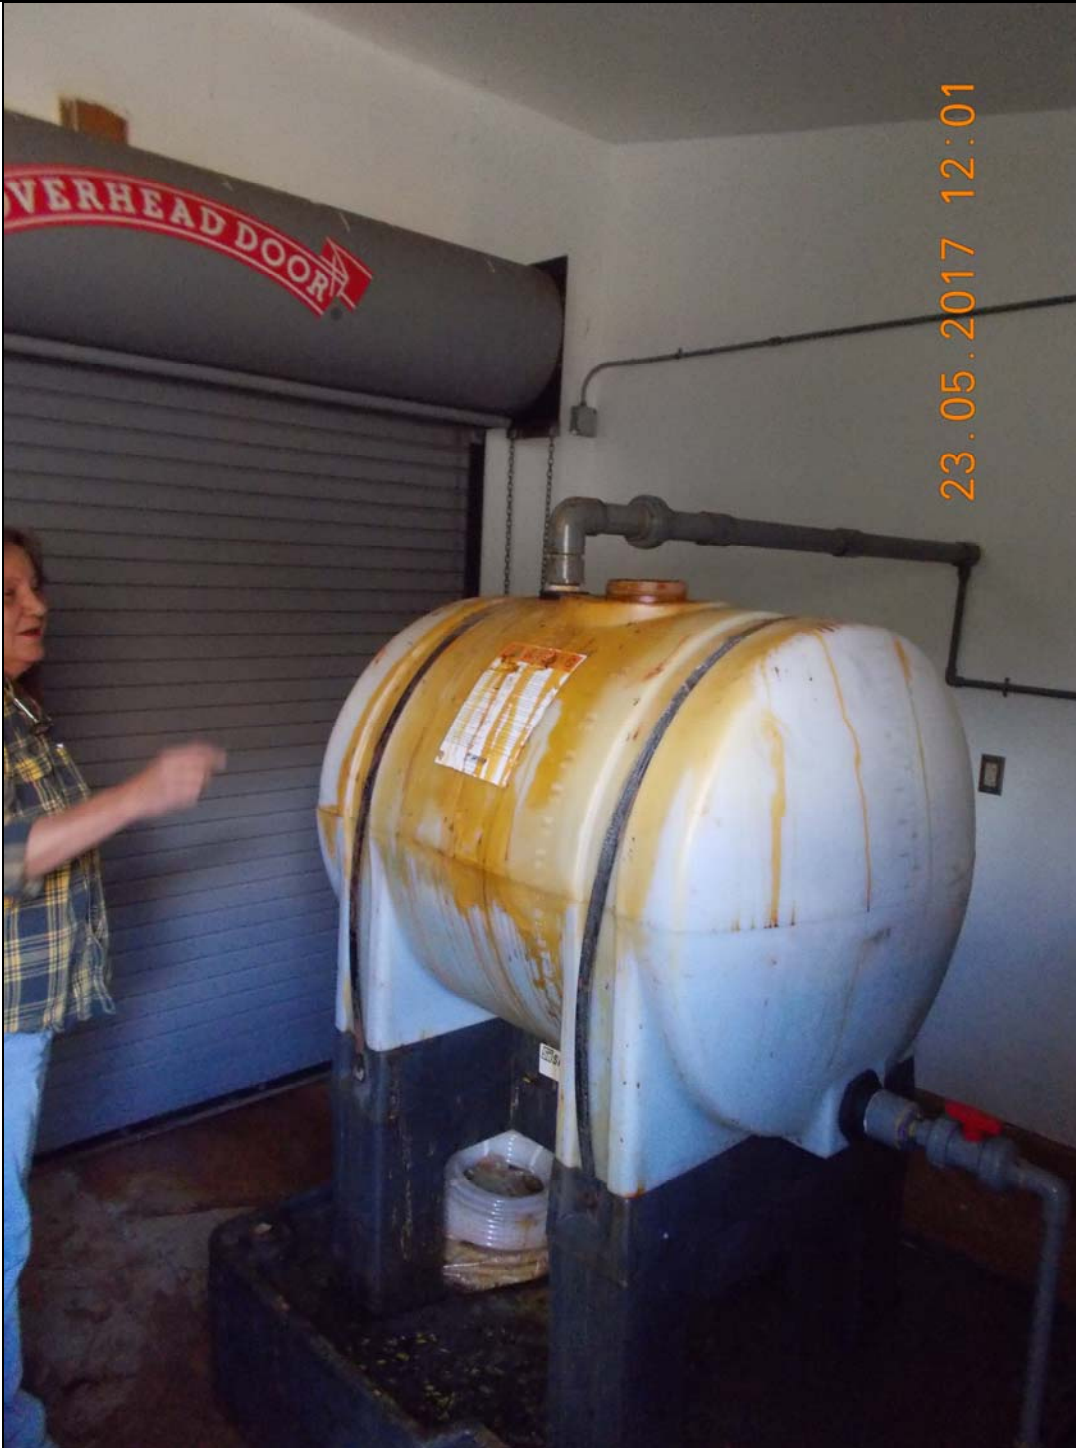
**NMED/SWQB
Official Photograph Log
Photo # 6**

Subject: Tertiary treatment for Total Phosphorous removal includes dosing of Ferric Chloride. The storage of the liquid material, barrels and the distribution system is housed in a single building. There is no secondary containment and improper ventilation. Overflow and spillage was observed. Corrosion was observed on the walls ceilings and staining on the ground outside the building was observed by inspectors. This creates a risk for the operators and potential carry over to the river.

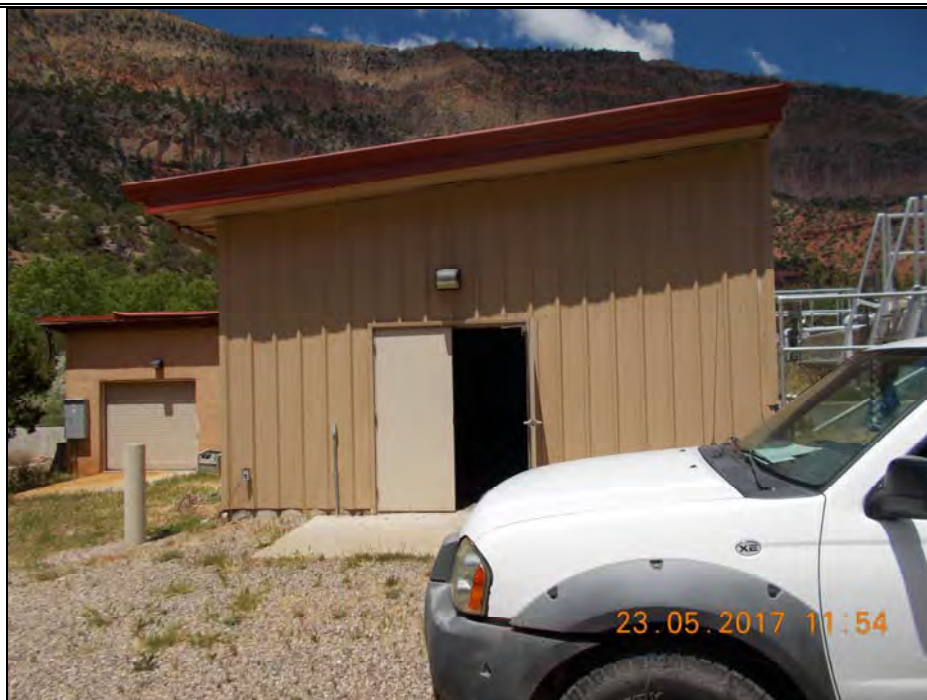
**NMED/SWQB
Official Photograph Log
Photo # 7**

Subject: Stains on the ground in the building to the left of the photo where the Ferric Chloride is stored.

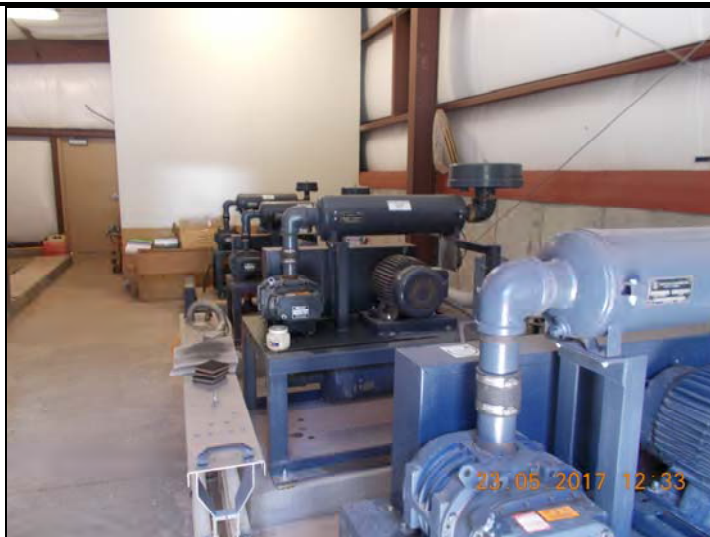
**NMED/SWQB
Official Photograph Log
Photo # 8**

Subject: Four blower for the aeration basins: One was in use at the time for the basin in operation and one was in use for the sludge thickener basin.

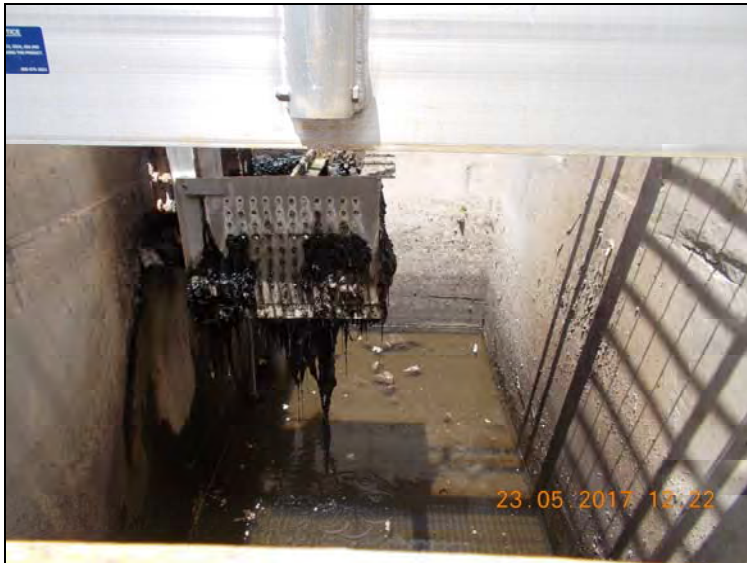
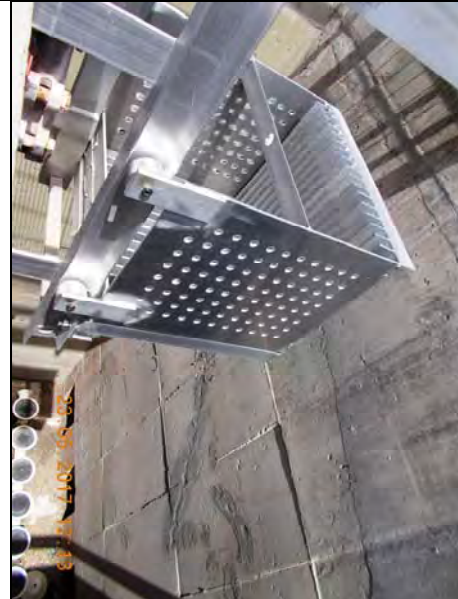
**NMED/SWQB
Official Photograph Log
Photo # 9 & 10**

Subject: From the headworks raw sewage is sent to the equalization basins, used to control the flow into the aeration basins. New filter baskets were install in the last year to capture large solids that get past the first lift station filter. A flaw in the plant design is that there is no actual bar screen so these catch basket are used. Large solids were observed in the aeration basins. These baskets help remove solids but do not capture all. One treatment train is in use (left photo) and one train is off line (right photo).

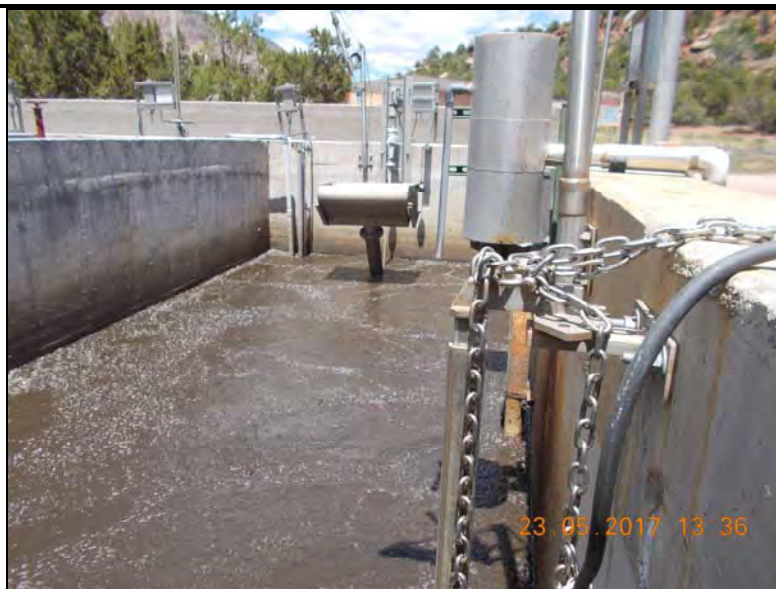
**NMED/SWQB
Official Photograph Log
Photo # 11**

Subject: Aeration phase in basin. Well distributed air throughout the basin.

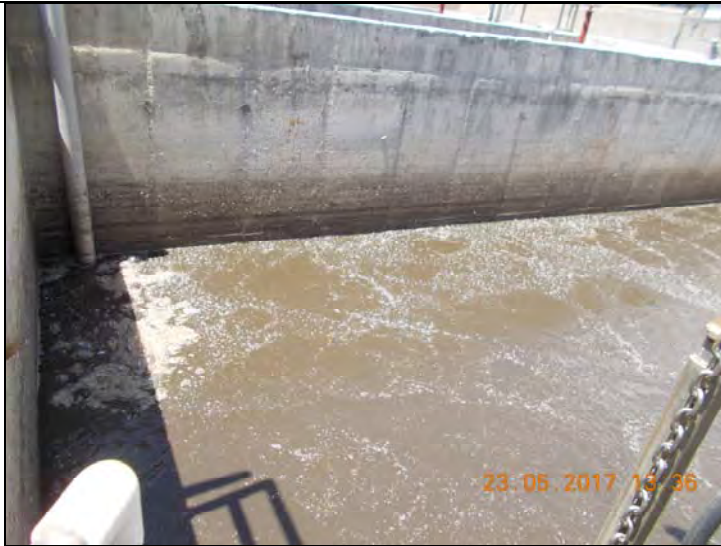
**NMED/SWQB
Official Photograph Log
Photo # 12**

Subject: Aeration Basin is slightly grey because solids are being kept longer to deal with thin influent.

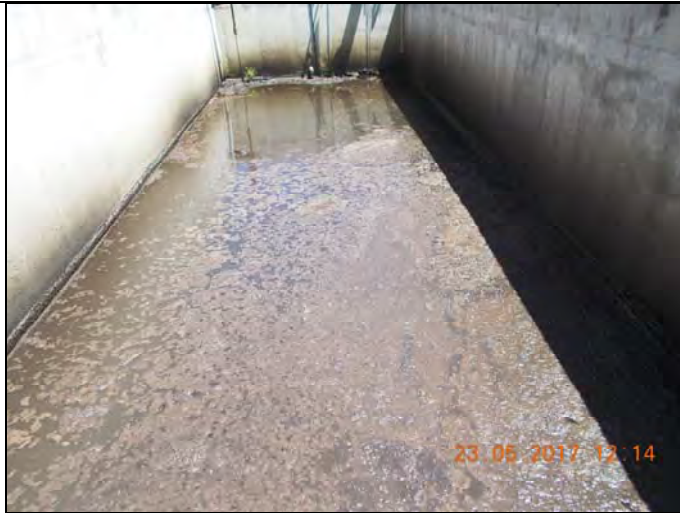
**NMED/SWQB
Official Photograph Log
Photo # 14**

Subject: Sludge aerobic digester, Waste solids are sent to the basin. A septage hauler removes solids from here.

The Village of Jemez Springs as the NPDES permittee is responsible for meeting the requirements for 40CFR 503 regulations and maintaining records of testing and final disposal of solid waste. The permittee's representatives stated they did not know the final disposal site and have never tested the solids before being collected by the contract hauler, therefore an Unsatisfactory rating is found for this section.

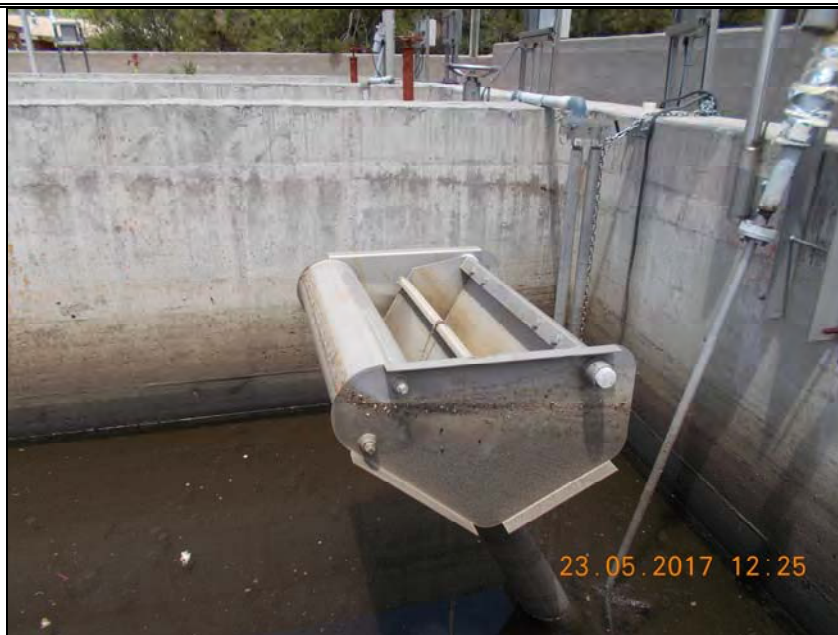
**NMED/SWQB
Official Photograph Log
Photo # 15**

Subject: decant arm in basin some floating solids were observed.

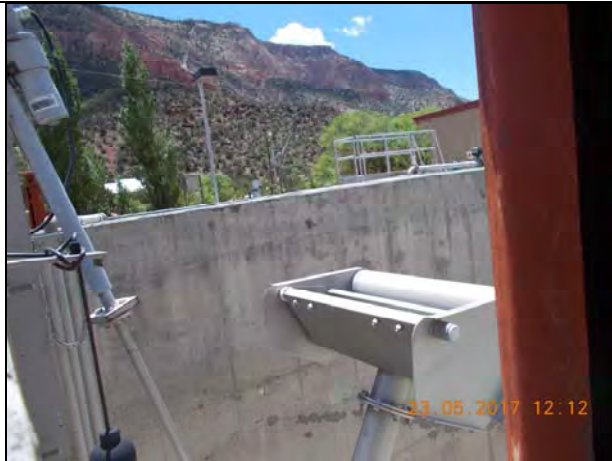
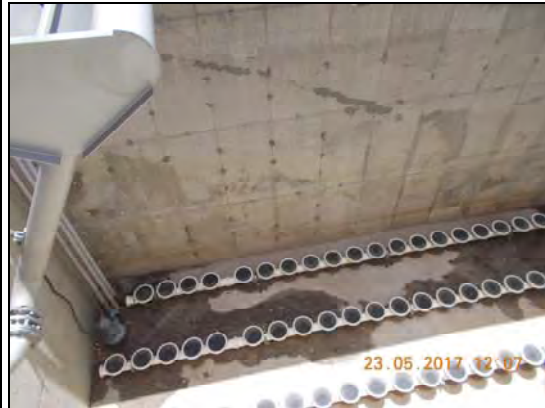
**NMED/SWQB
Official Photograph Log
Photo # 16 & 17**

The hydraulic decant arm in the first aeration basin was broken and chained up (see attached photo). This basin was not in use at the time of the inspection. However, in the event maintenance needs to be done in the second basin, the facility will have no back up treatment.

Subject: Off line basin

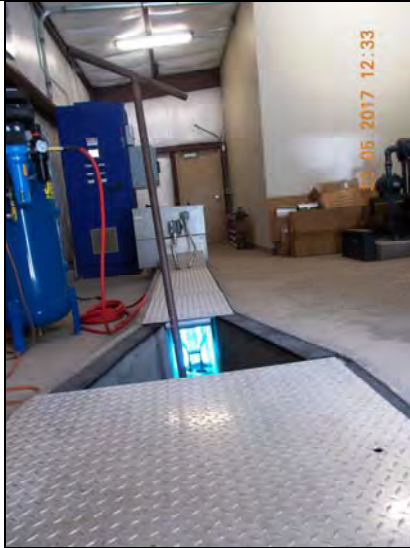
**NMED/SWQB
Official Photograph Log
Photo # 19**

Subject: UV disinfection channel – all lights were operable and clean at the time of the inspection.

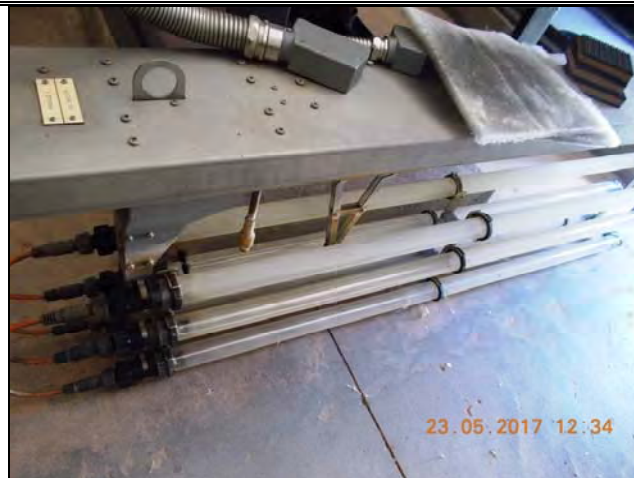
**NMED/SWQB
Official Photograph Log
Photo # 20**

Subject: Extra lights being cleaned.

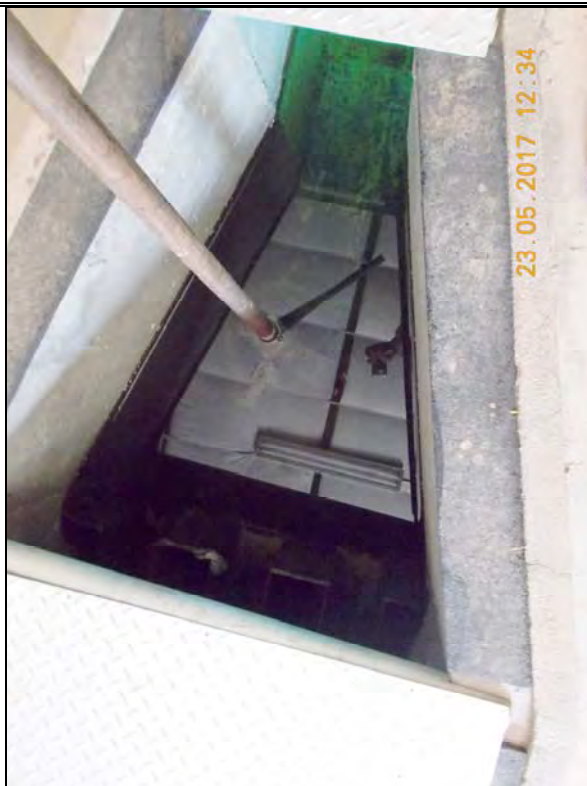
**NMED/SWQB
Official Photograph Log
Photo # 21**

Subject: UV basin some solids noted at bottom of basin.

3. Broken air distribution pipe in bottom of basin needs to be repaired or replace before use.
4. UV basin cleaning – some submersed solids were noted in this basin.

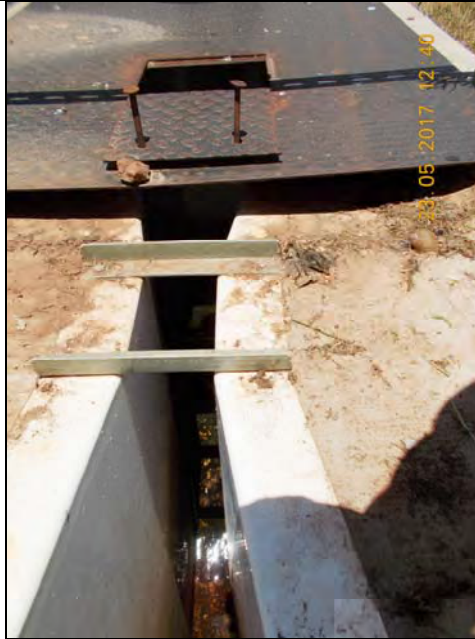
**NMED/SWQB
Official Photograph Log
Photo # 22**

Subject: New Effluent Flow meter is a six inch Parshall Flume with staff gauge and an ultrasonic sensor.

4. CALIBRATION FREQUENCY ADEQUATE. (DATE OF LAST CALIBRATION <u>No records after flow meter was installed</u>) RECORDS MAINTAINED OF CALIBRATION PROCEDURES. CALIBRATION CHECKS DONE TO ASSURE CONTINUED COMPLIANCE.	<input type="checkbox"/> Y <input checked="" type="checkbox"/> N <input type="checkbox"/> NA <input type="checkbox"/> Y <input checked="" type="checkbox"/> N <input type="checkbox"/> NA <input type="checkbox"/> Y <input checked="" type="checkbox"/> N <input type="checkbox"/> NA
